# Detecting and Geolocating the source of GPS Interference

## Repeating antenna causing issues for Telco

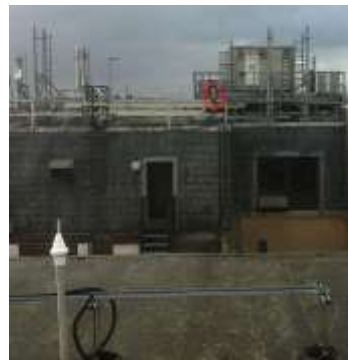
During one of the site visits the Chronos support engineers discovered that while on the roof both a hand held GPS receiver and two mobile phones were unable to obtain lock and showed significantly reduced GPS signal strengths. This confirmed the potential interference however it was not possible with this equipment to detect where the source of the interference was coming from given the amount of equipment located on the roof.

Repeating antenna is circled in red with GPS antenna in foreground

Chronos re-visited the site with handheld GPS interference detectors, CTL3500 and CTL3520, to determine the source of interference. Within a few minutes the source was discovered and located using the CTL3520 handheld with GPS direction finding capability. Once the offending antenna was detached, all the affected GPS systems reported stronger signals and began to lock.

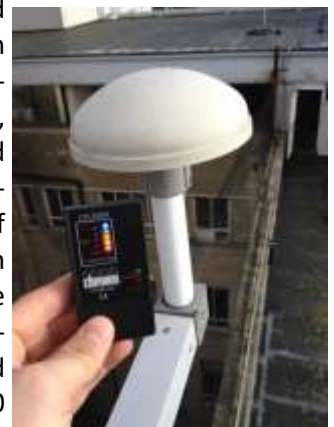
CTL3500 handheld GPS jamming detector
