GPS Jammer employed to defeat Company Fleet Tracking System

Major Telecom Operator's Timing Disrupted

CASE STUDY

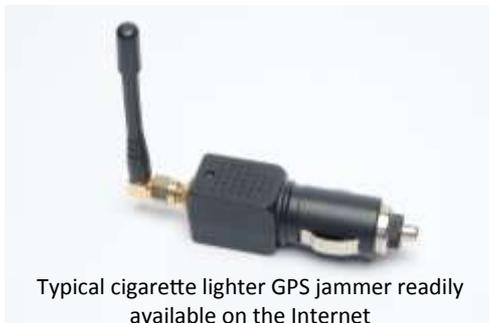
Typical cigarette lighter GPS jammer readily available on the Internet

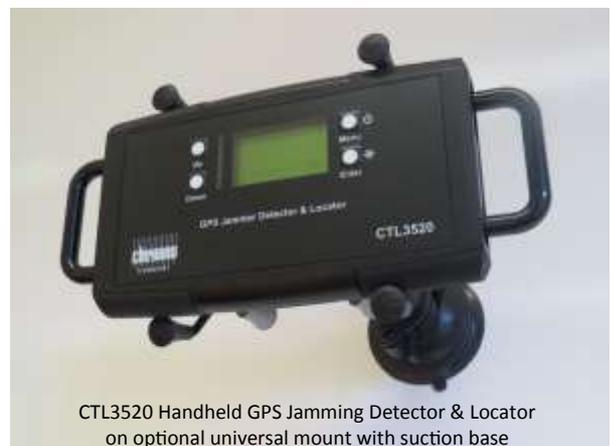
CTL3520 Handheld GPS Jamming Detector & Locator on optional universal mount with suction base

The next course of action was to issue a local engineer with handheld detectors—the CTL3510 Jamming Detector and the CTL3520 GPS Jamming Detector and Locator, and attempt to capture and locate the interference source.

were later downloaded and matched to the outage times seen by the SSU. The CTL3520 was then used to locate the source of the interference.

Using the CTL3520, the engineer was able to locate jamming signals coming from two vehicles both parked in the grounds of the plant equipment company.

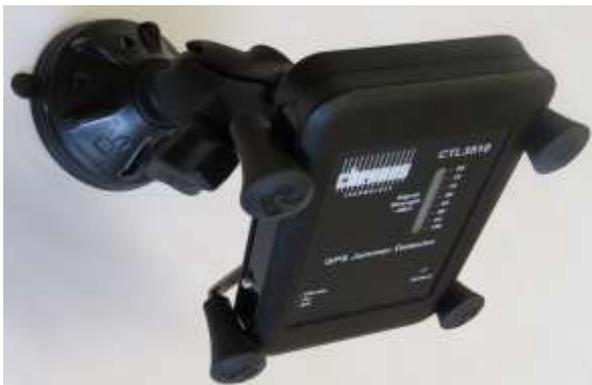
CTL3510 on optional universal mount with suction base

The sporadic nature of the events meant that a little luck would be needed for the engineer to be onsite at the time of an event. However, on the second and third site visits, the engineer was able to capture two jamming events in action. The CTL3510 was initially used to detect the presence of an interfering signal, the results of which
